Soil & Plant Considerations in Bioretentions in Fairfax County, Virginia

Urban Waters National Training Workshop
EPA Headquarters, Washington DC

A Fairfax County, VA, publication
October 18, 2018

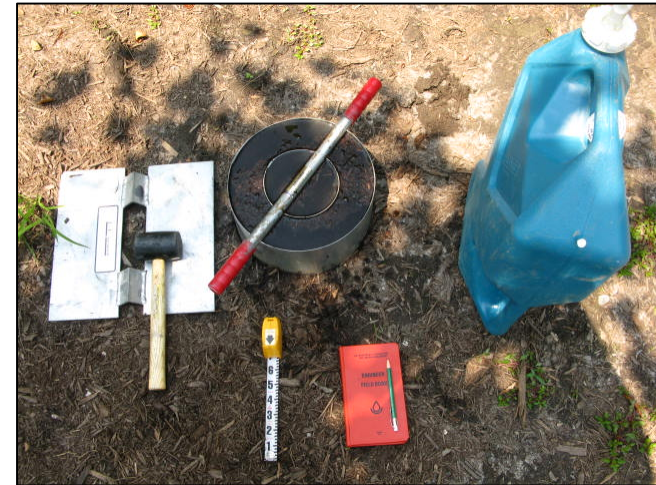
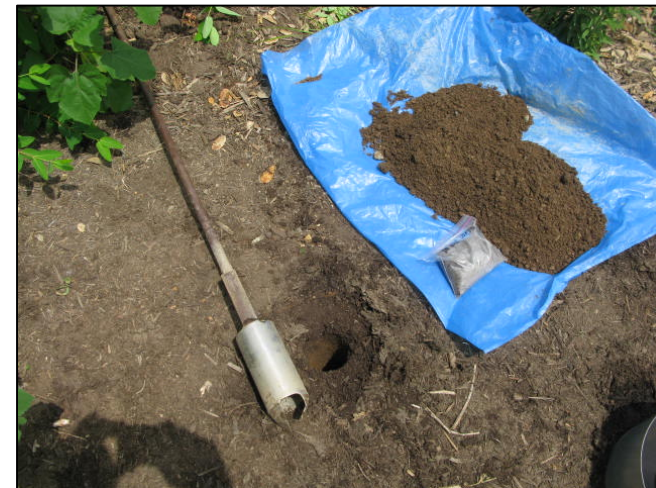
- Physical Survey
 - Ponding area - 67% less than design ponding depth
 - Soil media
 - Soil media depth - 49% missing filter media depth of 6" to 2'
 - Infiltration rate – 55% had some level of impairment
 - Media particle size distribution (sand, silt, clay)- significant variations
 - No significant correlation found between clay and sand content and infiltration rates

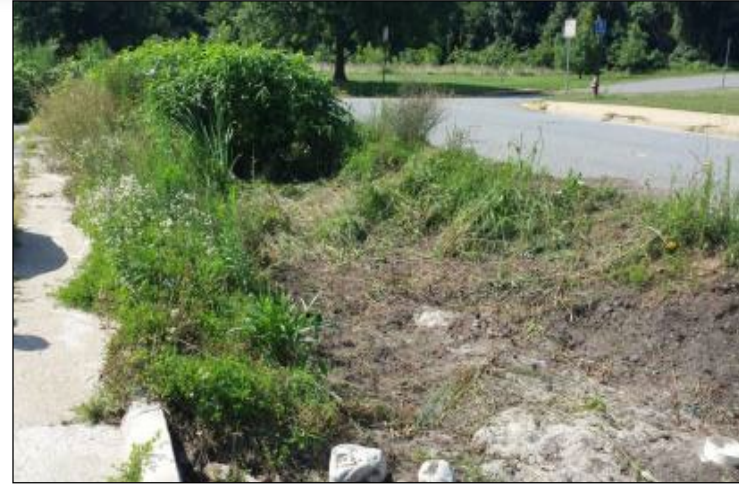
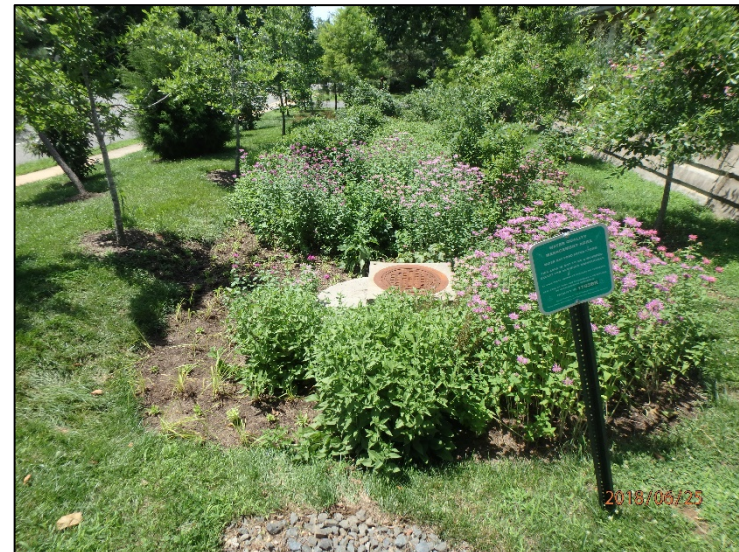
- Plant Survey
 - Survival rate of original plantings
 - Plant species that survived best
 - Dominant voluntary plants
- Weeds- Are they Bad?
 - Provide cover, protect from erosion
 - Nutrient uptake

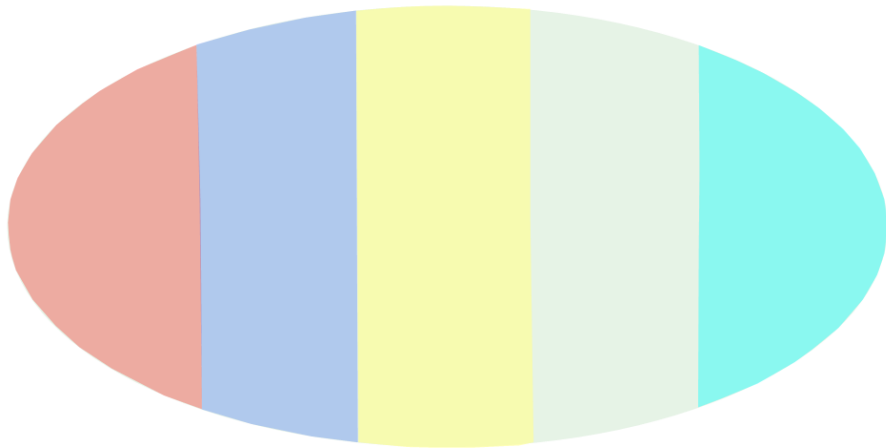
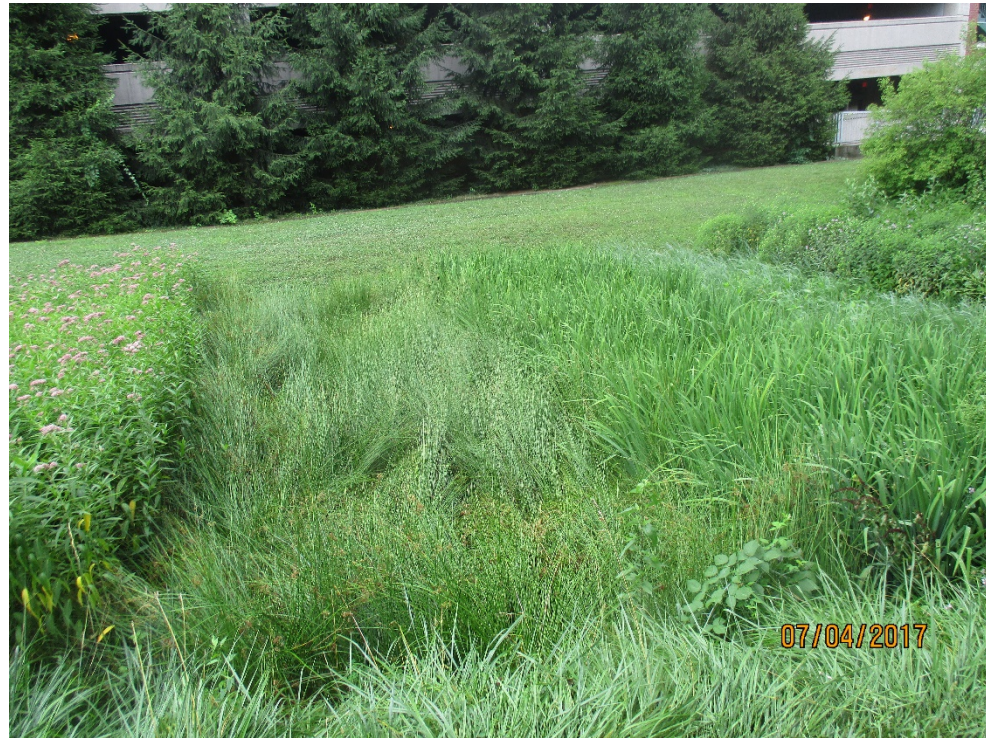
- Simplify planting palettes

-   Rudbeckia Fulgida var. Fulgida Black-Eyed Susan
-   Asclepias Tuberosa Butterfly Milkweed
-   Juncus Effusus Soft Rush
-   Iris Versicolor Blue Flag
-   Asclepias Incarnata Swamp Milkweed

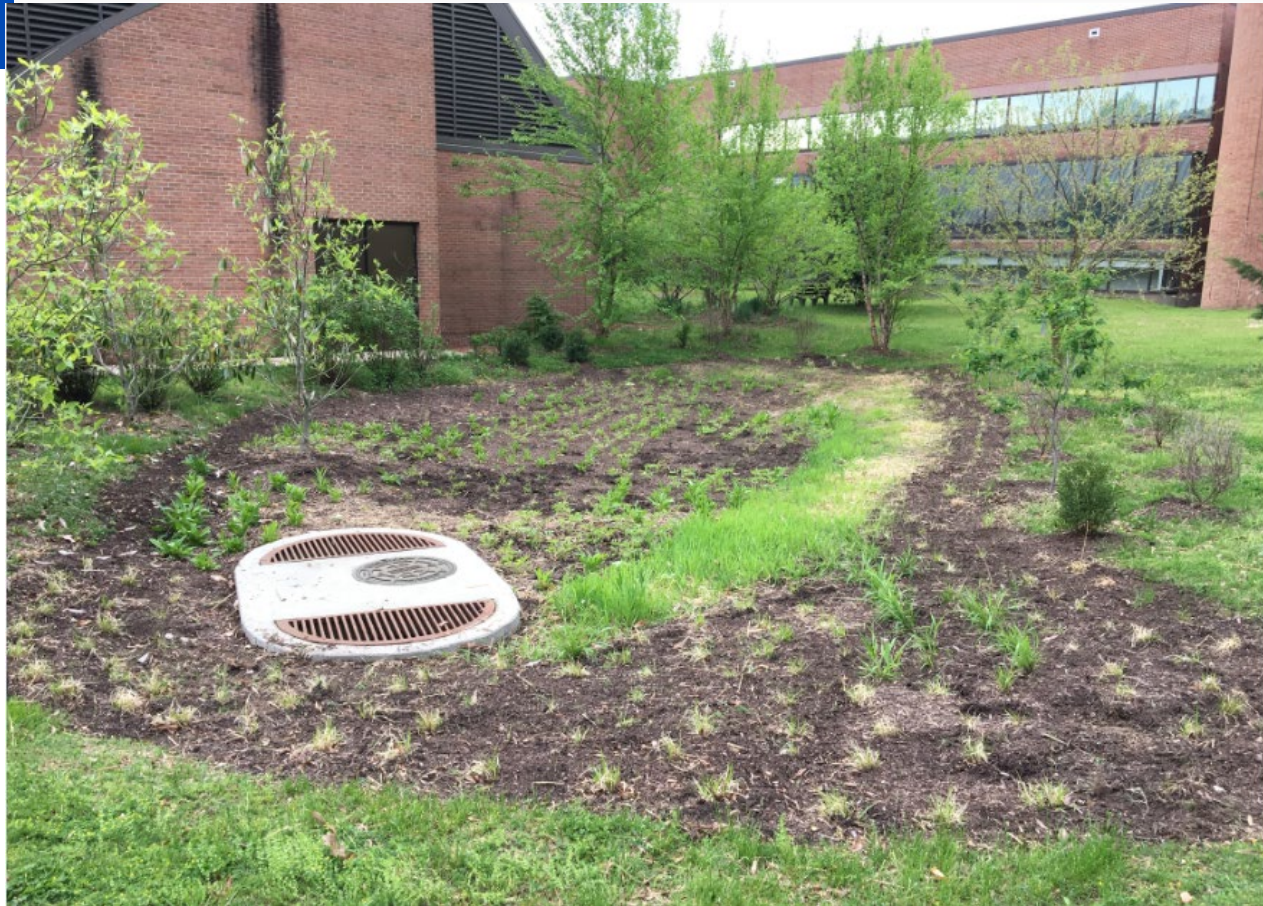
- Consequences of simplified planting plan
- What is the alternative?
- Reseeding?
- Limited interplanting?
